Character Appraisal and
Management Plan

Corringham Conservation Area

April 2023

Authored by Historic Environment Team,
Place Services, Essex County Council

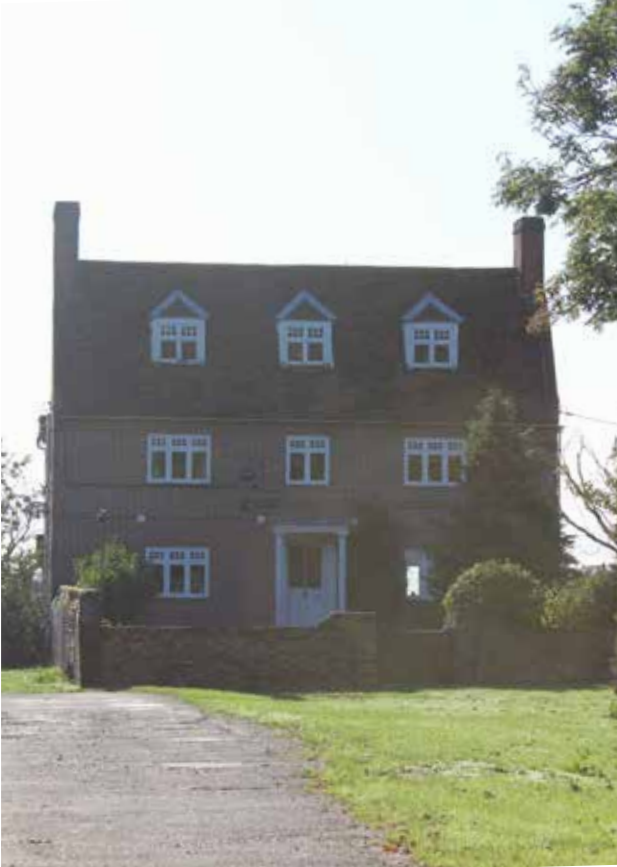
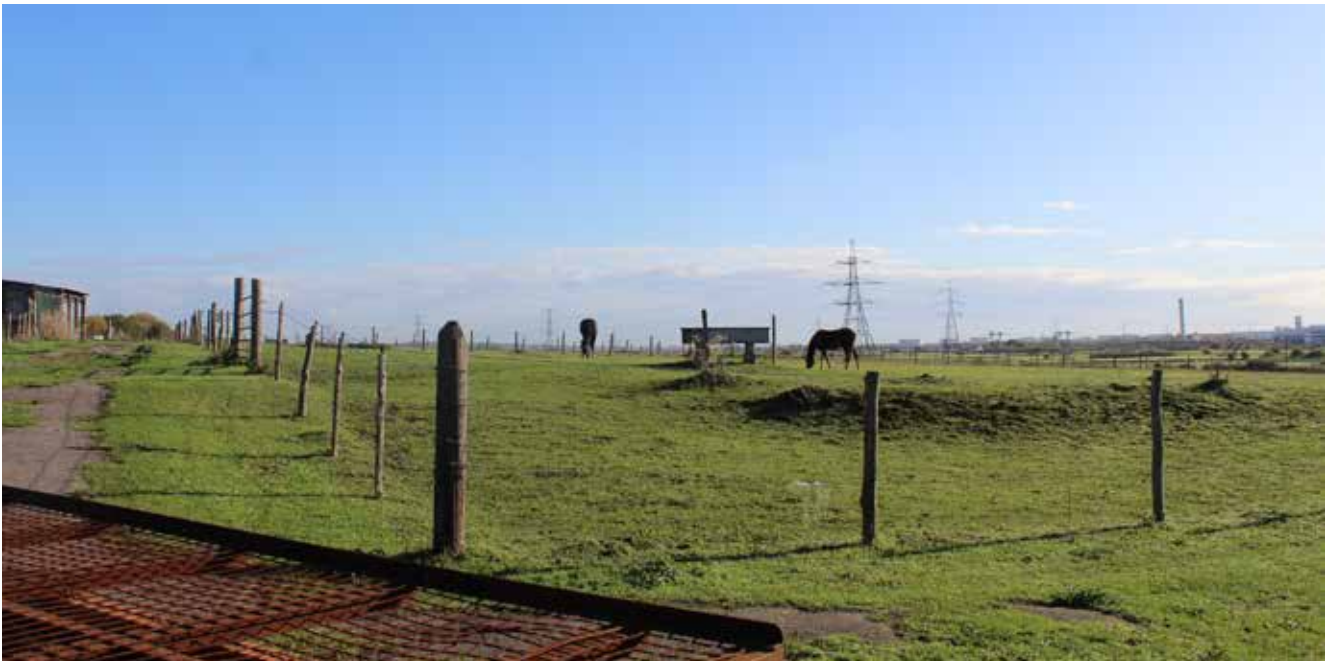
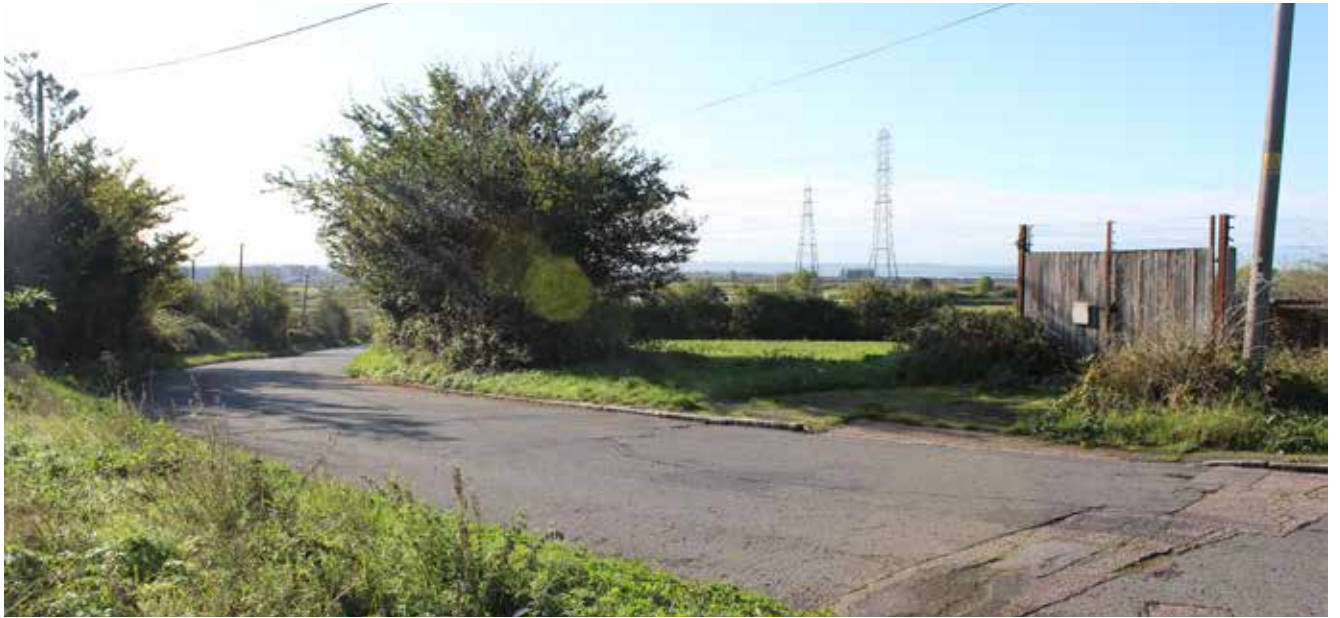
Figure 17-20 (clockwise from top left): Corringham Hall Complex

To the south of the Conservation Area is the gated entrance to the working farm at Corringham Hall. Within the farm is the eighteenth century brick Corringham Hall (Grade II Listed: 1111622), with an attached garden wall and associated farm buildings. The farm backs onto the open fields at the crest of the hill, which descends to the former Corringham Marsh and the River Thames. This creates an open, rural character to the Hall complex with long views over the marshes towards the modern industry along the River.

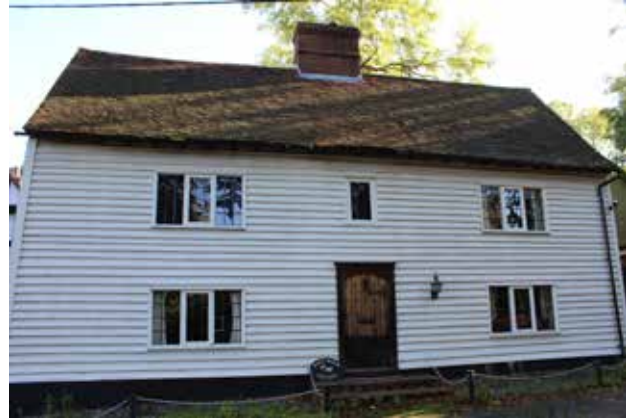
Figure 26: Numbers 1 and 2 Hall Farm Cottages (Grade II Listed 1111621)

On the east of Church Road is a close-knit row of vernacular buildings fronting onto the pavement. Numbers 1 and 2 Hall Farm Cottages (Grade II Listed 1111621) are located near to the south end of Church Road, overlooking the Church of St Mary and its churchyard. This building is timber framed and weather-boarded, constructed between the late sixteenth and early seventeenth century. It makes a positive contribution to the historic character of the area, along with its large garden containing mature trees to the rear.

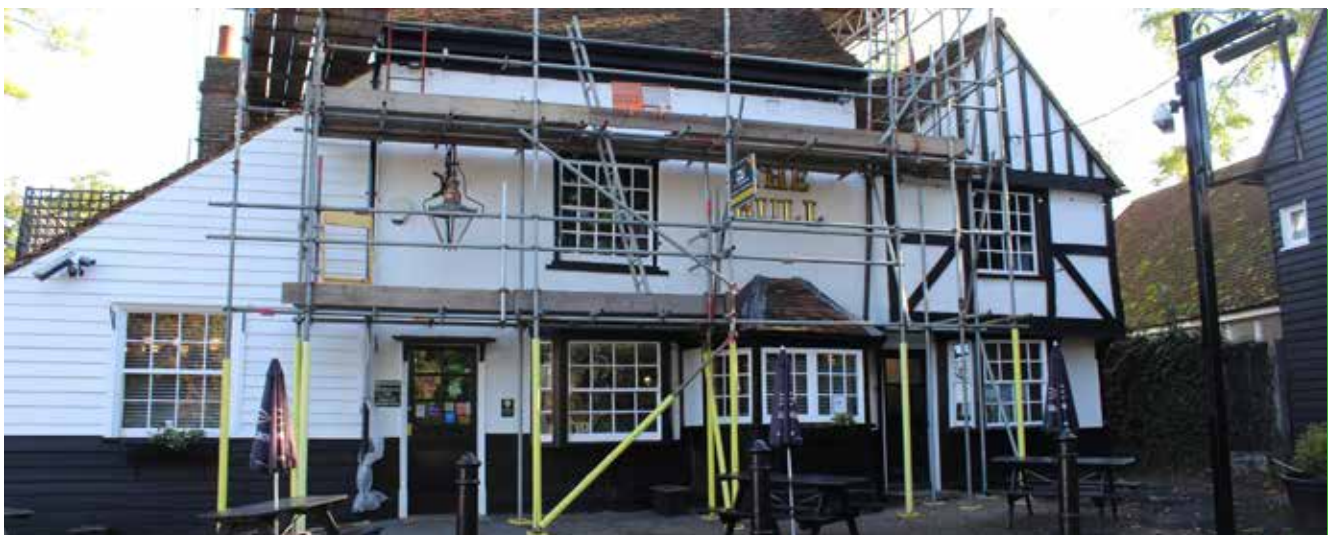
The Bull Inn also overlooks the open churchyard to the west. The Inn's core is timber framed and jettied with pantile roofing, and has eighteenth century weather-boarded extensions to the north. The building is set back from the road behind a small area of paving currently used for benches and outdoor seating and marked by bollards, and has a large rear yard used mainly for parking and a small garden. It is of communal and historic value to the Conservation Area, contributing to the only group of community spaces within the Conservation Area, comprising the church, churchyard and green. The footpath beside the Inn crosses over Church Road and continues into the churchyard.

Figure 28-31 (clockwise from top left): Images of the Bull Inn

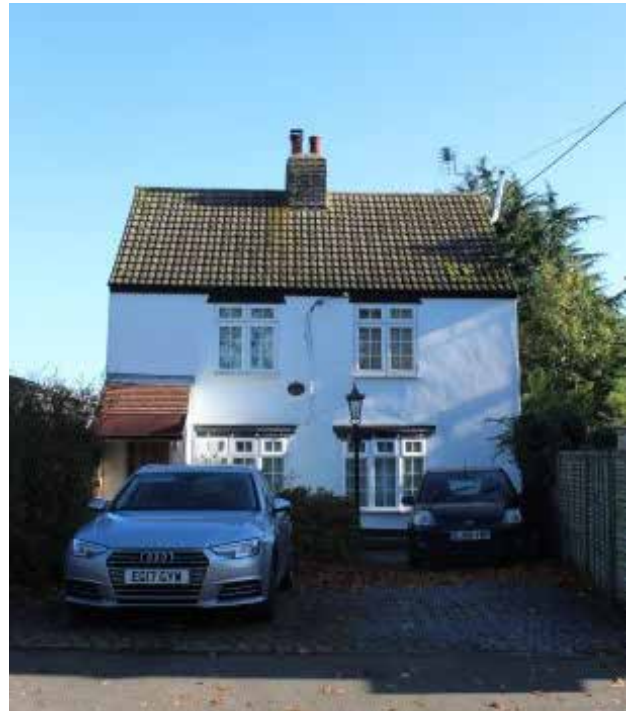
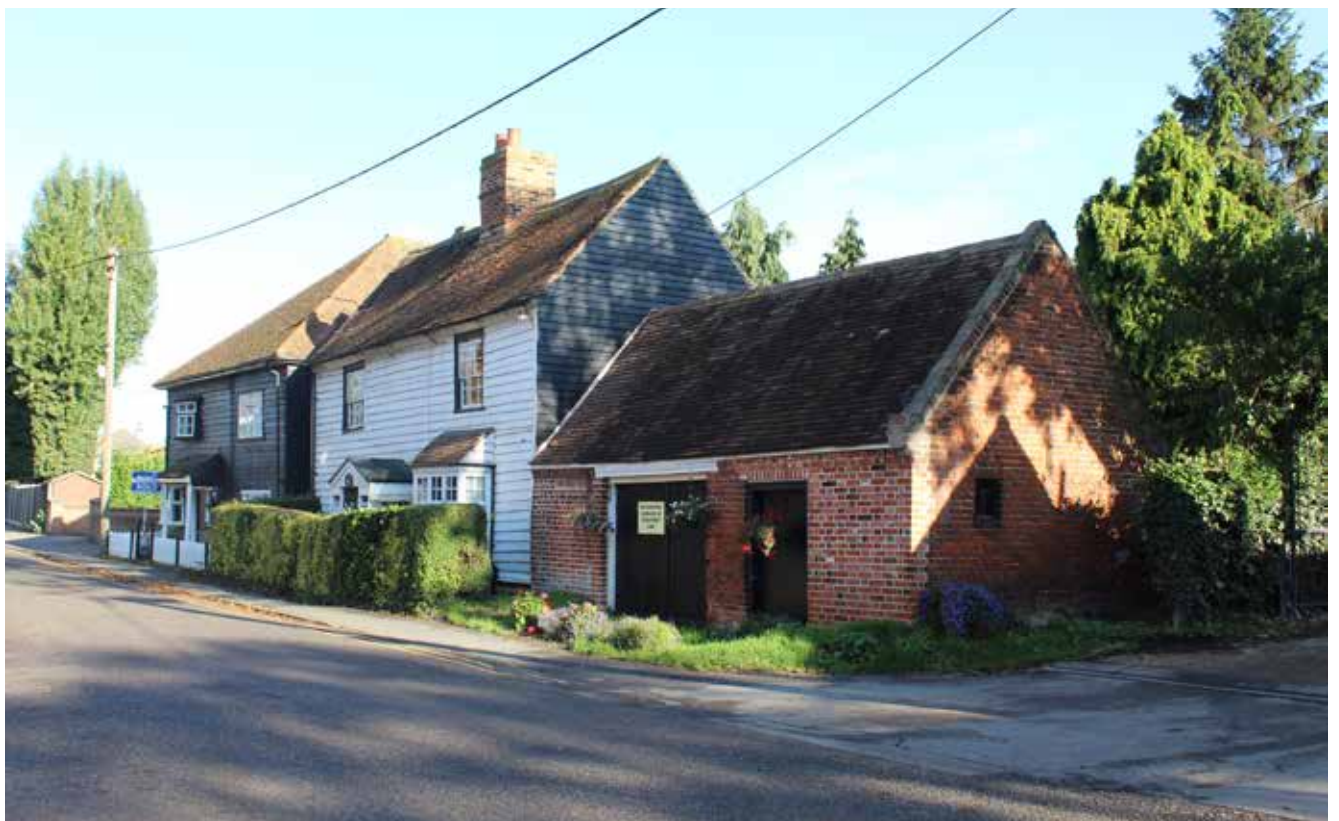
To the north of The Bull Inn is the timber framed and weather-boarded Bell House (Grade II Listed 1111619). This building is set behind a small front garden with low box hedge boundary, and has a garden with trees to the rear. Numbers 3 and 4 Ainsworth Cottages are located to the immediate north of Bell House, and make a positive contribution to the historic character of the area. Constructed in the eighteenth century, they are clad in black painted weather boarding under a pantile roof, with an oriel window on the first floor. They have a small front garden bounded by a low white picket fence, and long rear garden. Numbers 1 and 2 Ainsworth Cottages, constructed in the nineteenth century, to the north are set back from the pavement with a brick wall to the north and close boarding to the south. They are also important to the historic character of the Conservation Area.

Figure 32 (top): Bell House, and Figure 33 (bottom): Ainsworth Cottages

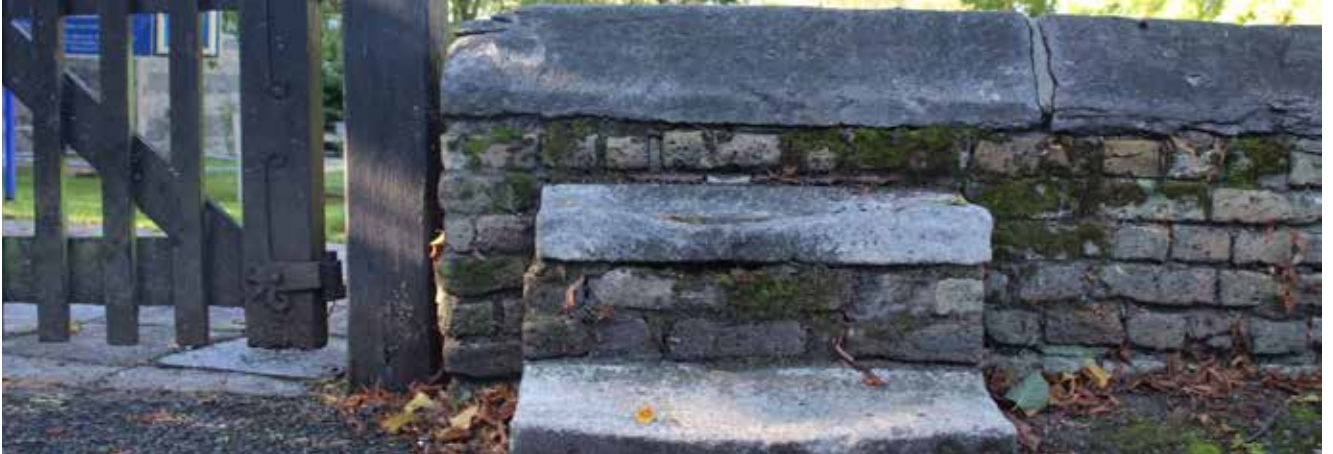
Figure 34: Boundary wall of the Church of St Mary

The Church of St Mary and its churchyard are bounded to the east by Church Road, the west by Rookery Hill, the south by Corringham Hall and the north by Church Cottage. The roads create an island, with the church located in its centre. The church is set within a large churchyard with mature boundary planting and a low stone wall. The late eleventh century west tower is dominant within its setting, and the church is isolated from surrounding buildings by the churchyard, roads and planting. This green, ecclesiastical core to the Conservation Area makes a key contribution of its special interest, enhancing our understanding of the origins and development of the settlement, and the historic and communal value of the area.

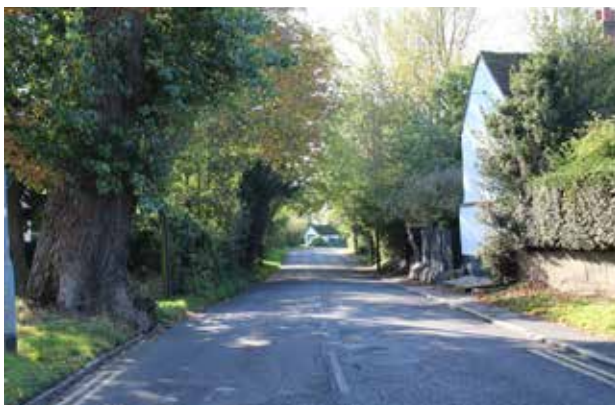
Figure 42 (top): Rookery Hill, and Figure 43 (bottom): Fearings Farmhouse

Located on Rookery Hill is the late sixteenth century Fearings Farmhouse (Grade II Listed 1337132). The former farmstead is set behind a high timber fence, however the farmhouse is visible from Rookery Hill, its timber-framed and plastered exterior under a red plain tile roof contributing to the historic character of the street.

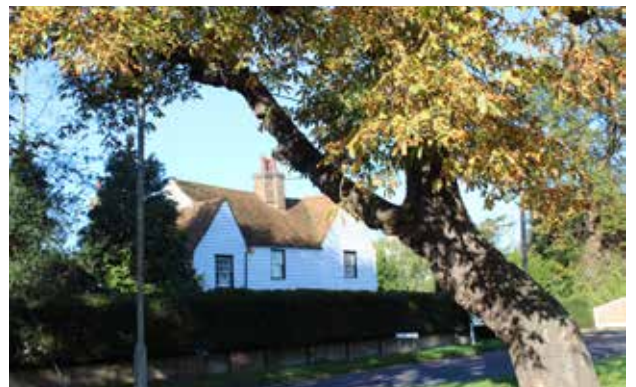
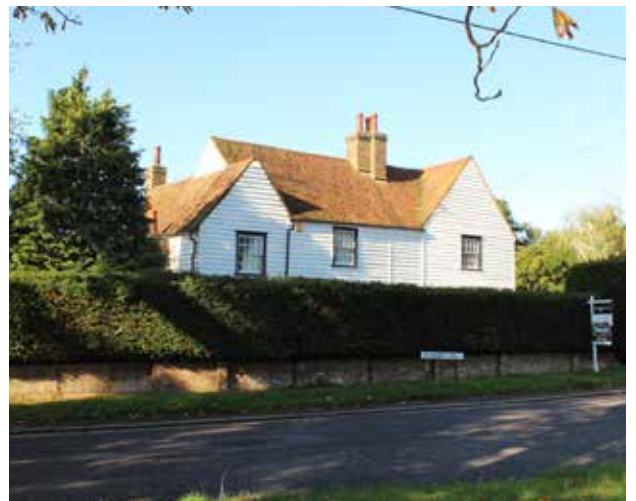
Figure 44 (top) and Figure 45 (bottom): Bush House

To the north is the sixteenth century hall house Bush House (Grade II Listed 1111562). This building is set back slightly further from the pavement behind a grassed verge and low brick wall with hedge row. The properties which surround Bush House are set within large gardens, with mature trees and hedges to the rear field boundary, creating a verdant backdrop to the buildings in this area.

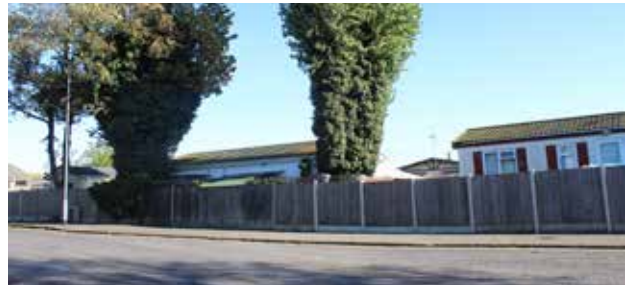
Figure 46: Chalet Park

Within the centre of the Conservation Area on the east side is a chalet park. This complex is largely concealed from view behind a tall timber fence, and the dwellings here are of a small scale. The chalet park is considered to have a neutral impact on the Conservation Area. The low height of the buildings reduces their visual prominence however they are untraditional in form, detailing and materials

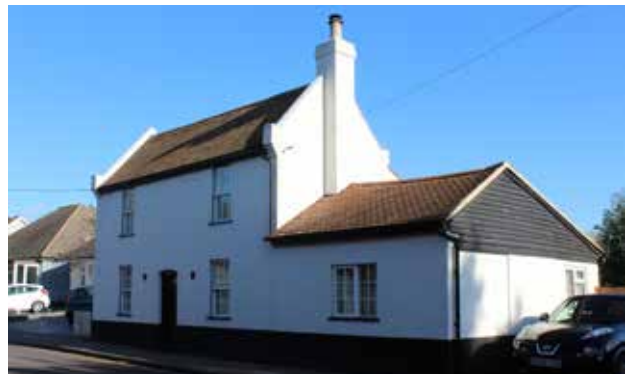
Figure 47: Rose Cottage

Further north is Rose Cottage (Grade II Listed 1111618), a late eighteenth century house in painted brick with red plain tile roof. It has retained its historic sash windows and simple eaves corbeling, making a positive contribution to the historic character of this area, particularly in contrast to its twentieth century surroundings.

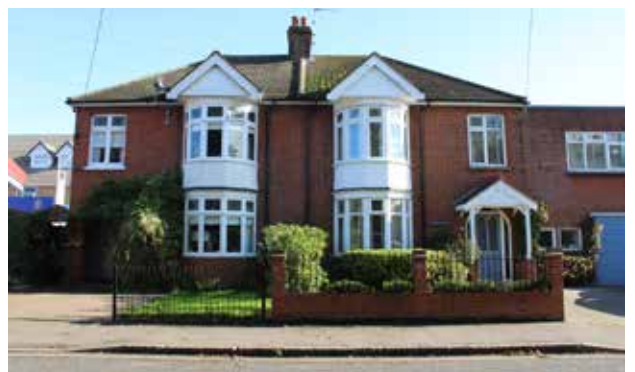
Figure 49: Pit House and Culham House

The northern boundary of the Conservation Area is marked by the late nineteenth century, semidetached Pit House and Culham House, which are set behind small front gardens planted with shrubs with low red brick boundary wall and iron fencing. Pit House has retained its recessed porch and original windows with stained glass lights; Culham House has retained much of its character, although an extension to the south, window replacements and a porch impacts the historic character and symmetry of the pair.

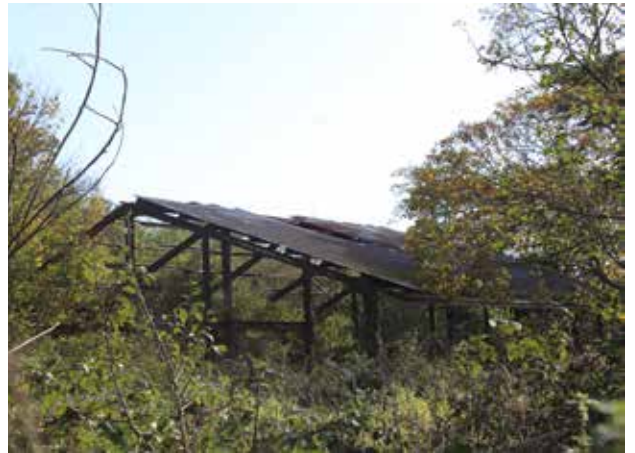
Figure 50: Structure remaining in the former Rectory grounds

To the north west of the Conservation Area are the grounds to the former nineteenth century Rectory, accessed from the tree lined Chestnut Walk. While the rectory has been lost and the Kashody Clinic which later replaced it has fallen into disrepair, parts of the Rectory grounds, garden features (including a tiled pool) and planting survive. Towards the rear field boundary of the grounds, a large metal framed structure clad in corrugated sheeting is in a poor state of repair and at risk of rapid deterioration. This has a negative impact on the appearance of the Conservation Area.

The former Rectory is a private site, although there is evidence of access informally via the tree lined Chestnut Walk and through missing fence panels which line the footpath here. The site is of historic interest, with the foundations and some walls of the former Rectory still discernible. The site is not currently maintained and is at risk of further deterioration. It appears to attract anti-social behaviour including littering and vandalism. Despite this, the site makes a positive contribution to the Conservation Area as private grounds, due to its former use, historic value, and its visibility from the road which allows it to contribute to the green character of the area.

- The site of former Rectory is a private site accessed via the tree lined Chestnut Walk. The site is of historic interest, with the foundations and some walls of the former Rectory still discernible. There is evidence that the site is being accessed through broken fence panels, with litter and graffiti within the grounds highlighting its use for anti-social behaviour. This area has potential for enhancement through the maintenance of existing boundaries, the stabilisation or removal of the metal framed structure within the grounds, and a considered approach to protecting and preserving any remaining features of the Rectory grounds.

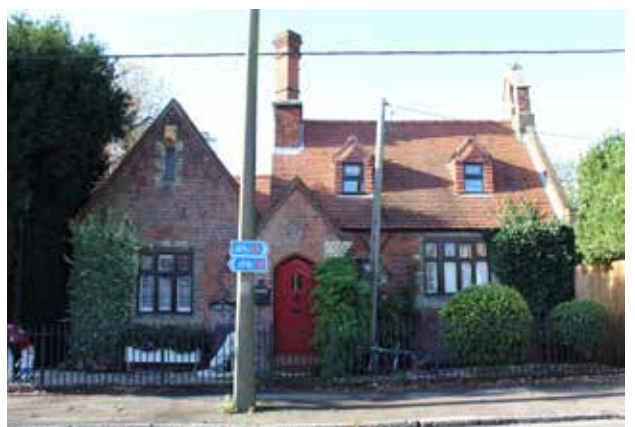
Figure 52: The Former School House

At the entrance to Chestnut Walk, the nineteenth century Arts and Crafts style Old School House is set behind a modest garden, bounded by iron fencing, facing onto Church Road. This building makes an important contribution to the character of the area, its red brick elevation with diaper work and varied roofline and chimneys are prominent in the streetscape, as well as marking the northern boundary of the Conservation Area.

The Old School House is a fine example of polychromatic (many colours) brickwork and although modest, is executed with great skill and harmonious detail.

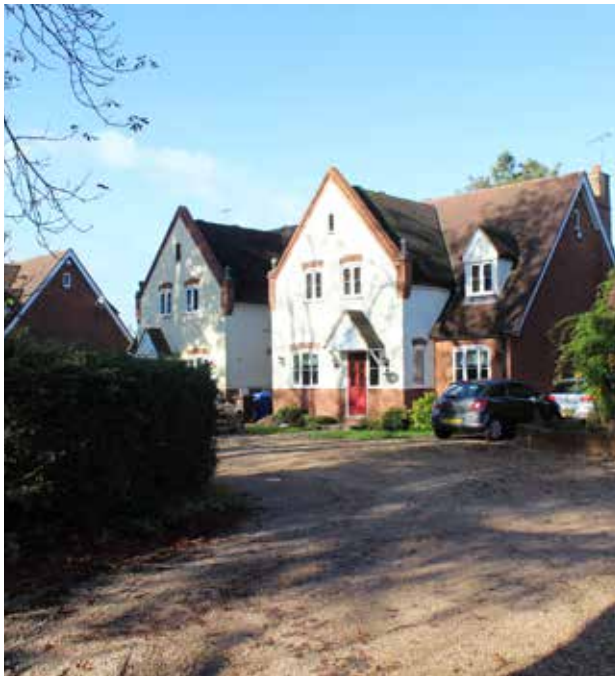
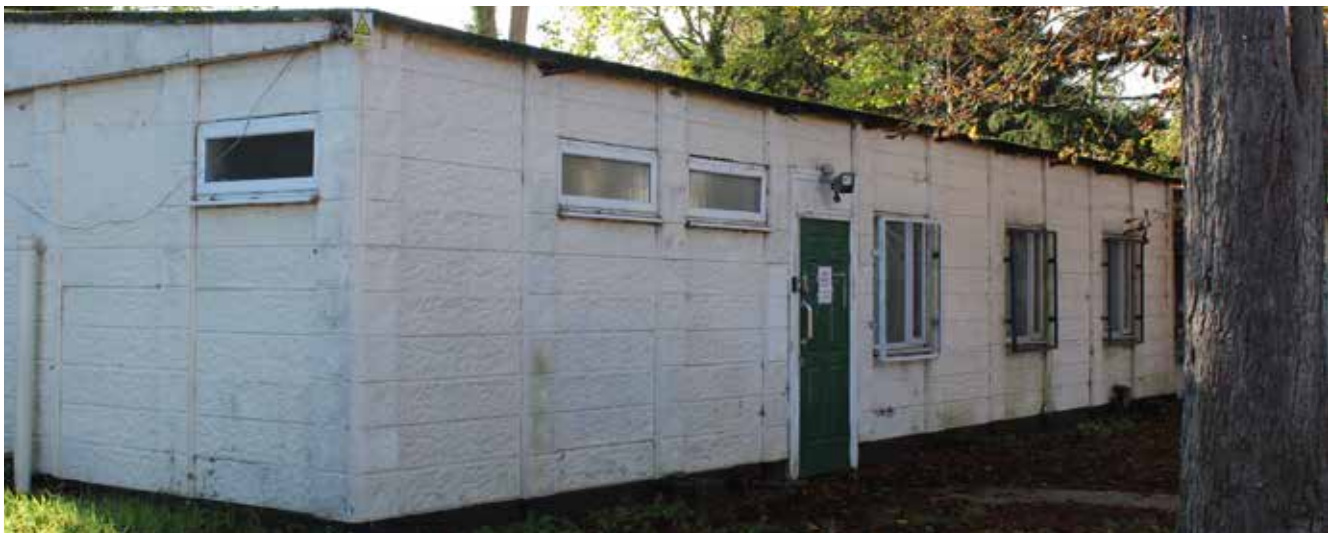
Figure 53-55 (clockwise from top left): Chestnut Walk

Along Chestnut Walk, an avenue of established trees contributes to the verdant character of the area and line the former entrance to the Rectory grounds. A modern development of houses to the north of Chestnut Walk and the Village Hall to the south make a neutral contribution to the character of the area.

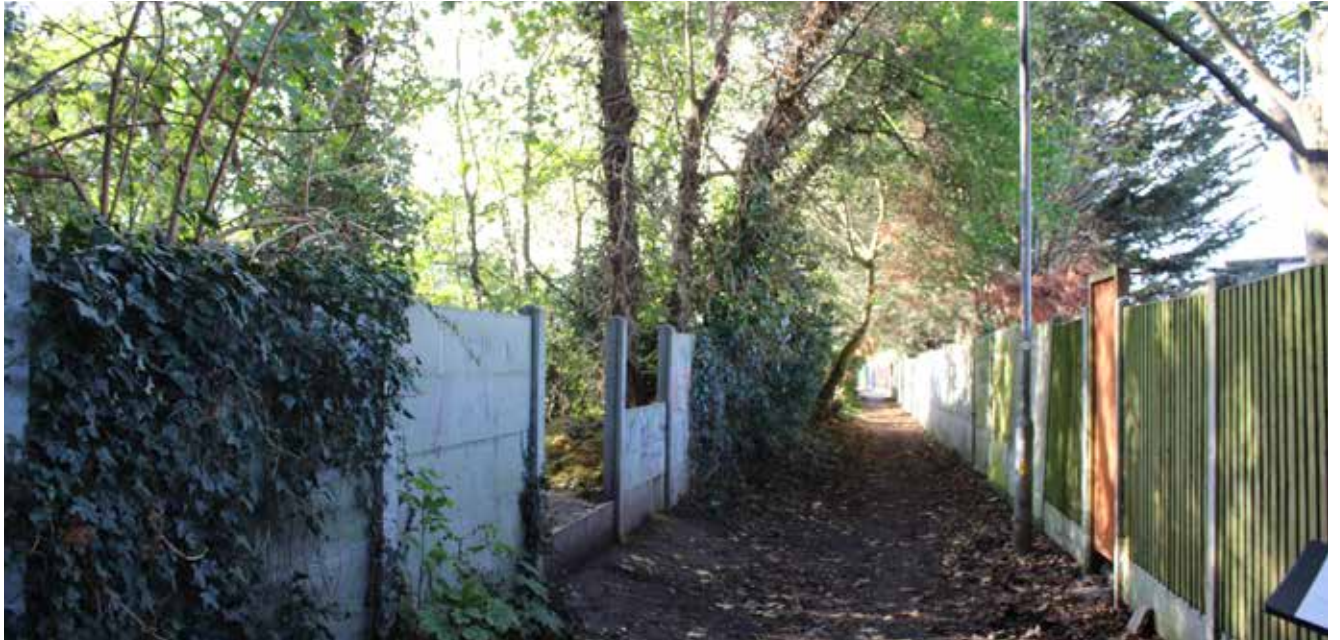
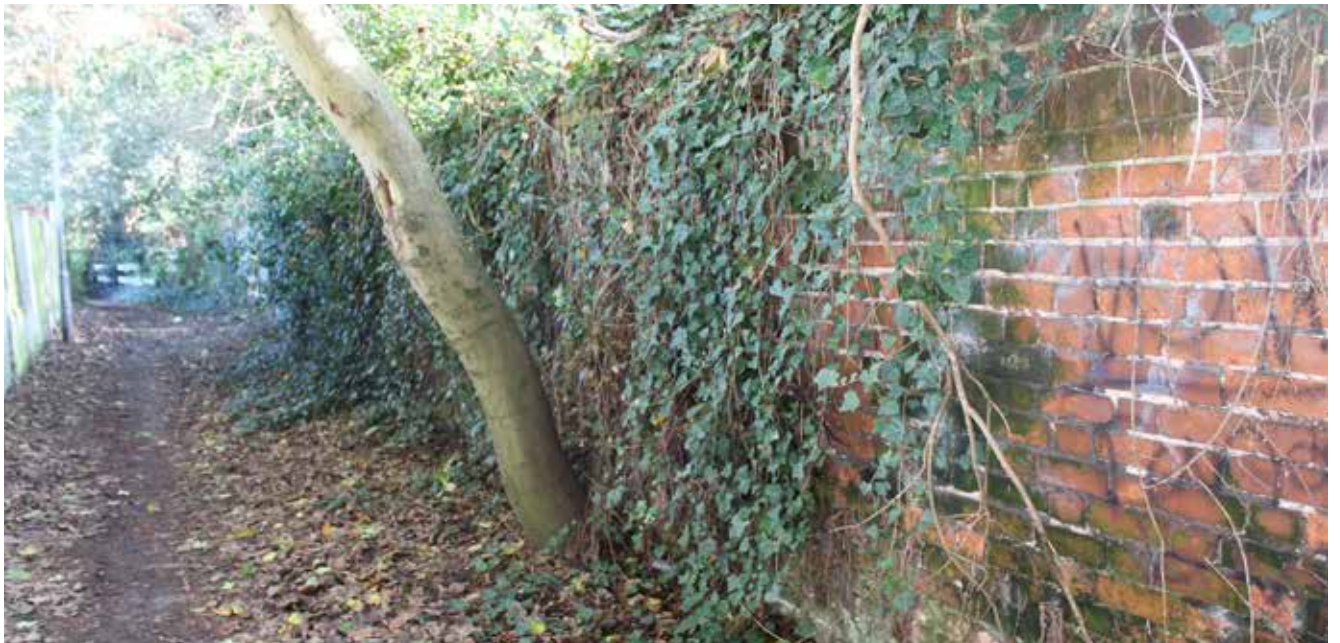
Figure 56 (top) and Figure 57 (bottom): Boundary treatment on footpath

Chestnut Walk continues to the west to follow a footpath, which is bordered predominantly by close board and concrete fencing. This is deteriorating in places, often overgrown with ivy, with some panels

missing. There are parts of the wall which incorporate historic red brick boundary walls of the Rectory, however these are also at risk of deterioration.

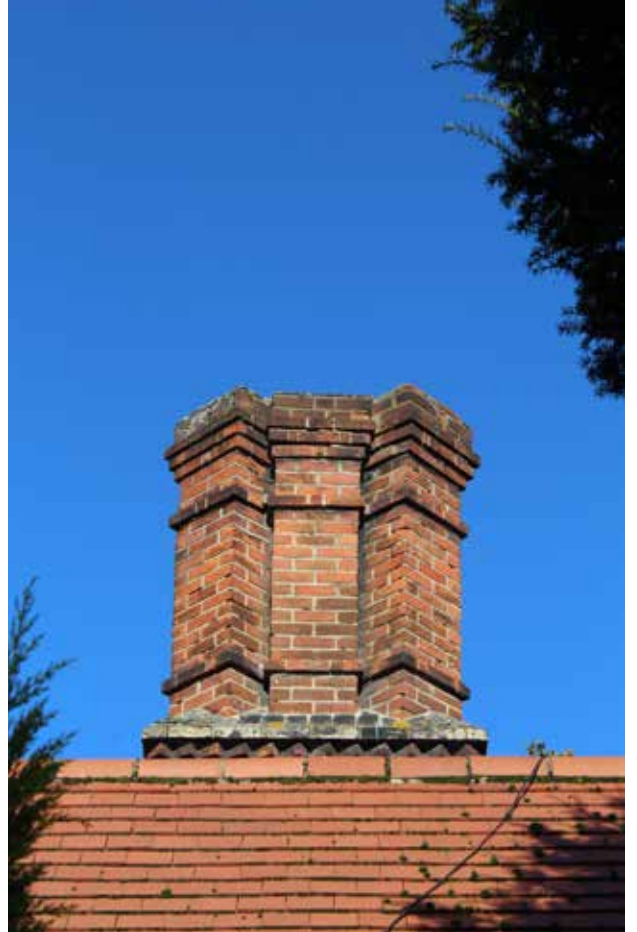
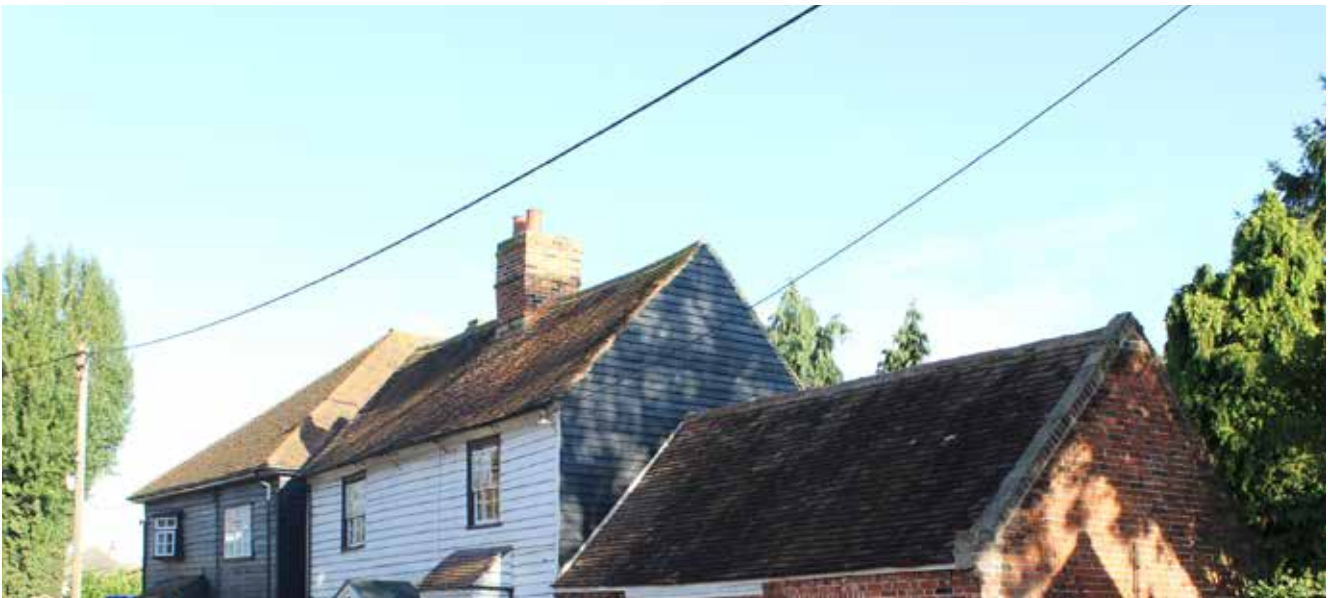
With the exception of the Church of St Mary, all the buildings within the Conservation Area are either one or two storeys, with the majority of positive buildings being the latter. Steeply pitched roofs and brick chimneys provide a characterful roofscape.

The proportions and massing of timber framed structures are the result of their historic construction which did not allow for long single spans. Whilst gables feature prominently in views, buildings tend to be parallel to the road resulting in a lower perceived overall building height.

Figure 58-60 (clockwise from top left): Examples of roofing

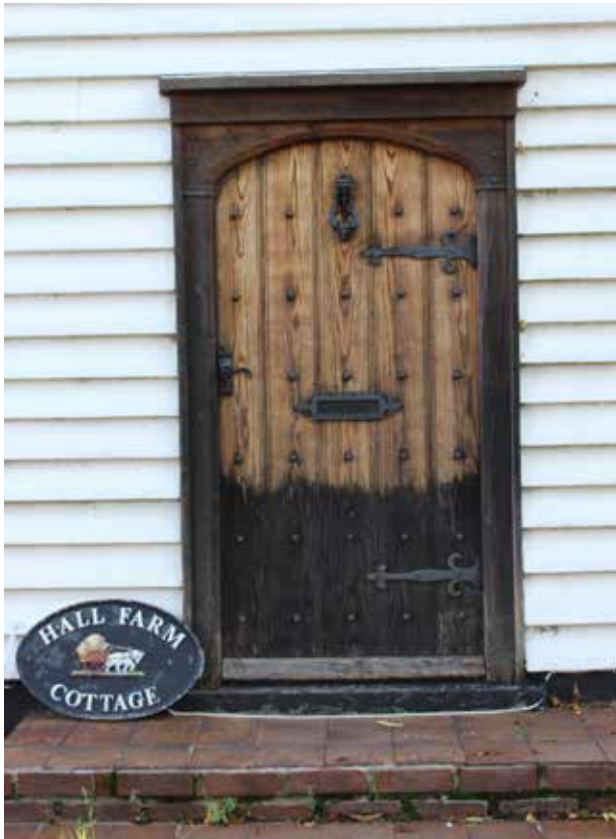
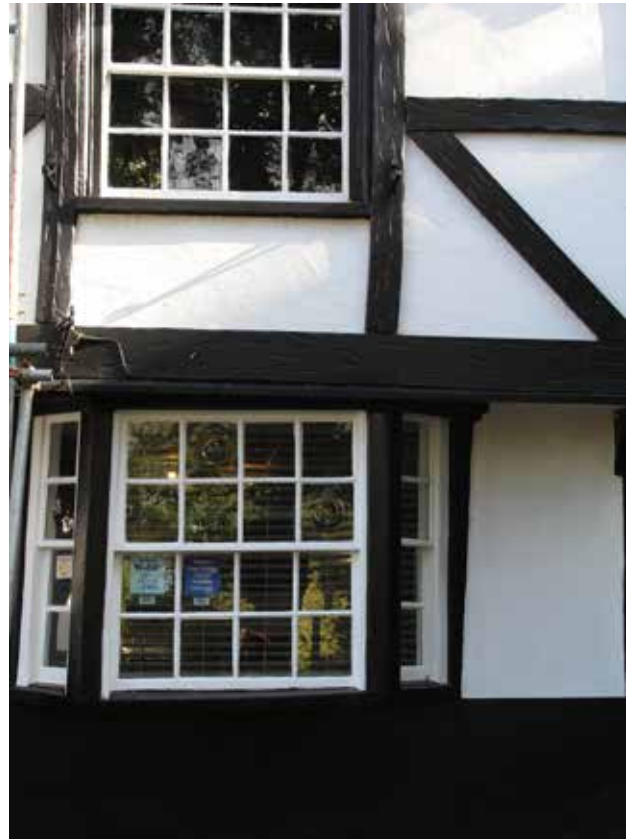
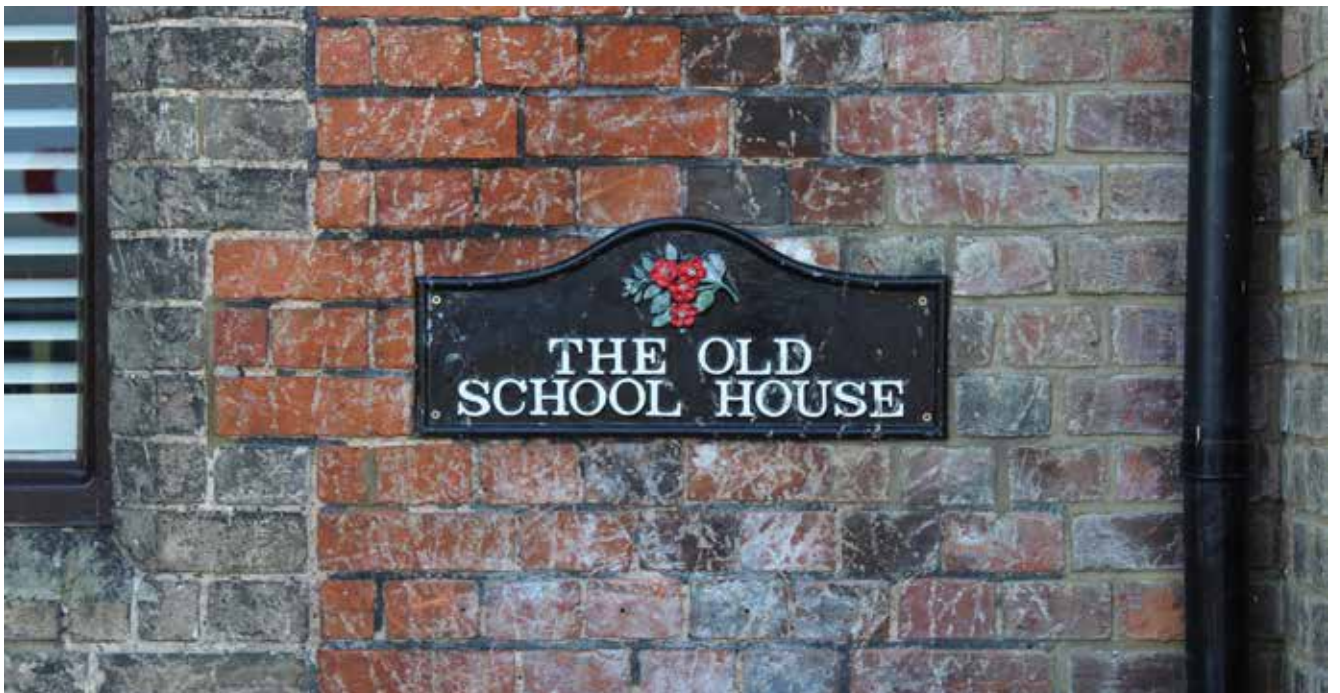
Figure 65-67 (clockwise from top left): Material palette

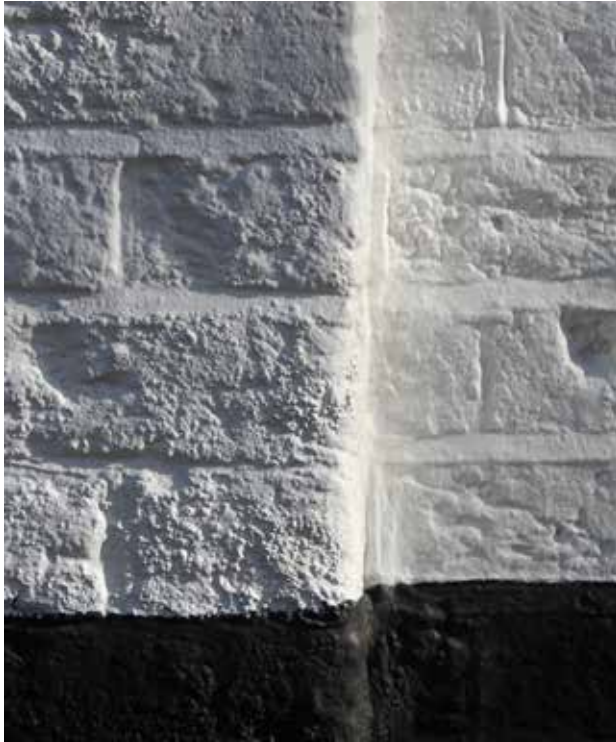
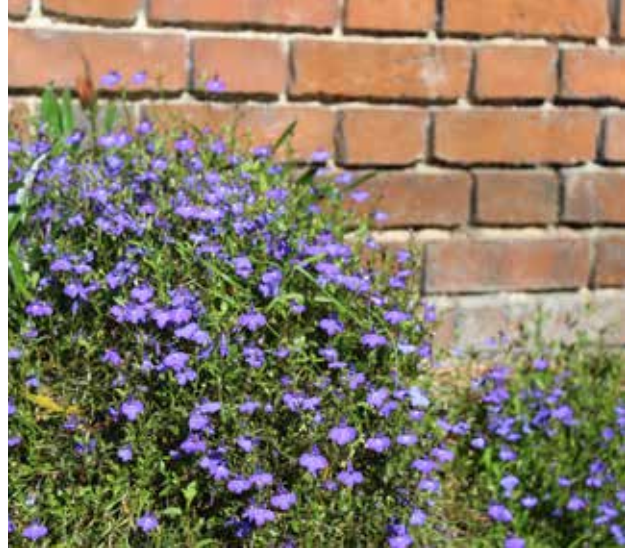
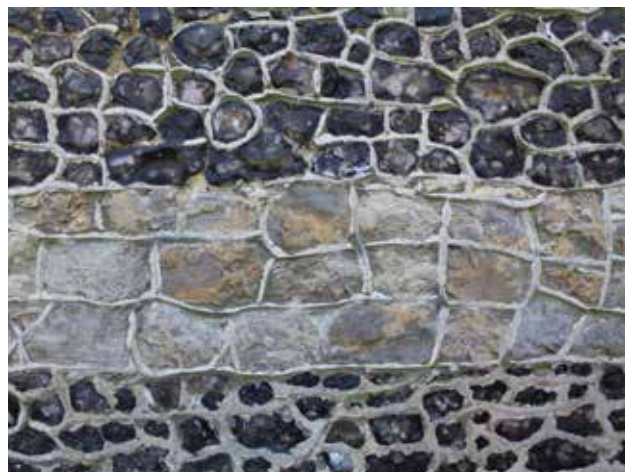
Figure 68-74 (clockwise from top left): Material palette

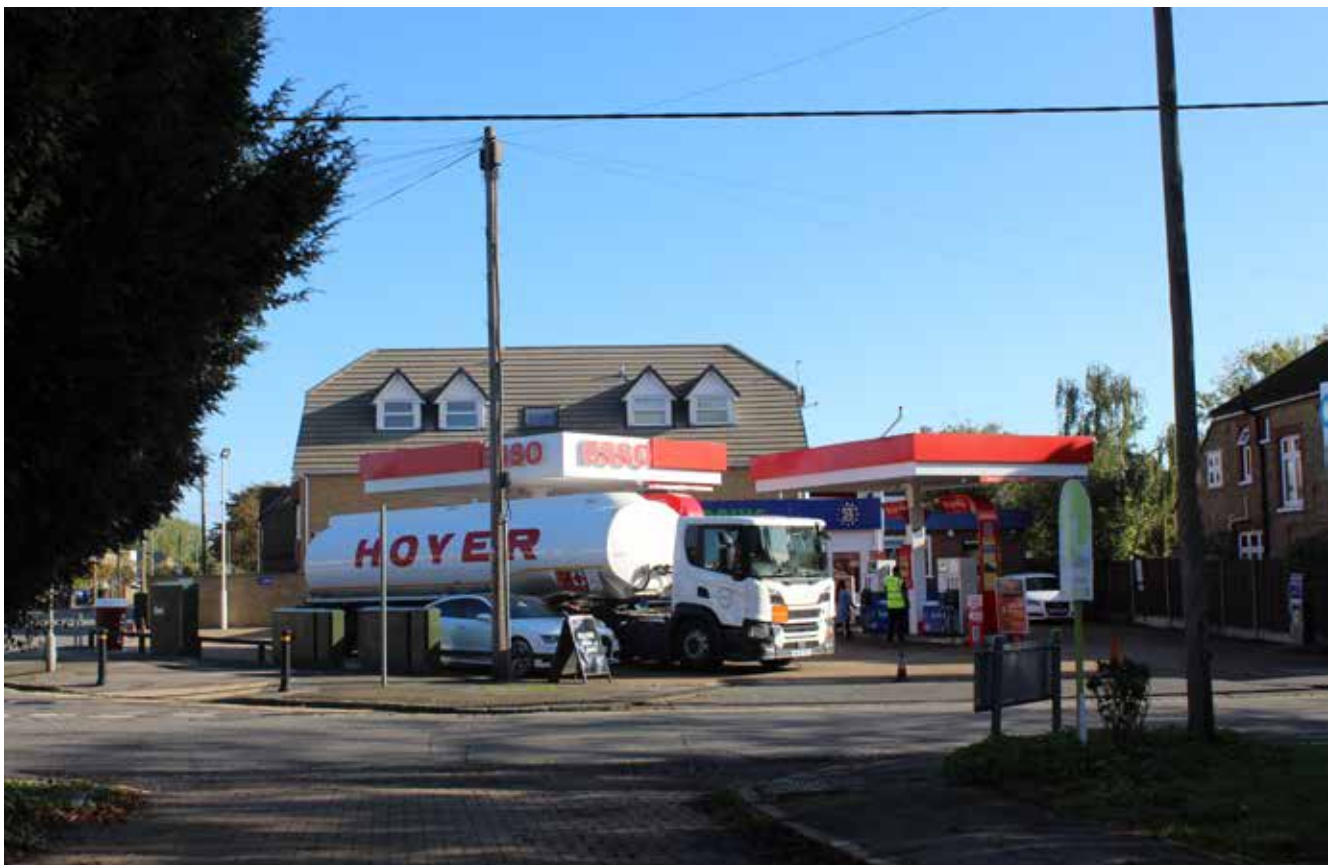
Figure 79: View east towards petrol station from the Conservation Area.

The large and extensive area of modern Corringham developed north of the Conservation Area, principally in the 1960s and 1970s. While this has not fundamentally impacted upon the historic village, the location of the petrol station does currently adversely affect the ability to experience and appreciate the significance of the Conservation Area. It is located at the gateway to the Conservation Area when approaching from the north; its bright colour palette, modern materials, street furniture, and regular vehicular access make the site an intrusive feature within the setting of the Conservation Area.

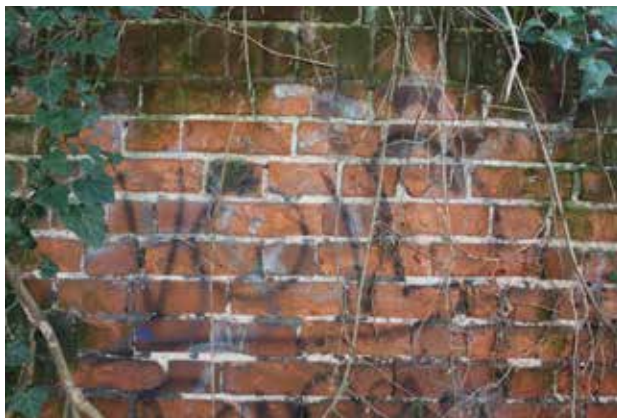
Access routes from the north west of the Conservation Area are currently in a poor condition as well, with graffiti and disrepair impacting the appreciation of the historic character of the area.

Figure 80: Example of graffiti on public right of way within the Conservation Area

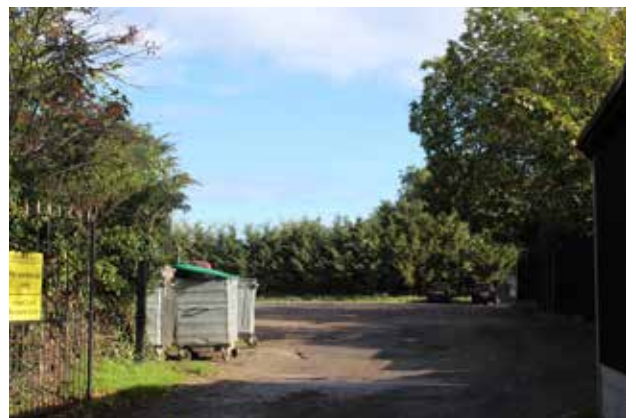
Figure 81: Car Park at the Bull Inn

Whilst it is necessary to provide adequate parking for church visitors and for walkers, there is currently extensive informal parking outside The Bull Inn which detracts significantly from the character and appearance of the Conservation Area, particularly within this small historic core, and intrudes upon the setting of the Grade I and Grade II listed buildings in the immediate vicinity. The Bull Inn is located adjacent to a large car park, which is visible from Church Road but largely screened in wider views from the Church of St Mary, which may alleviate some parking issues.

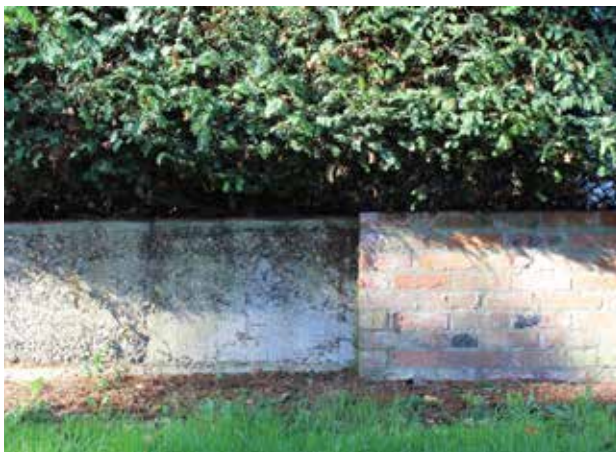
Throughout the Conservation Area, particularly on the north of Church Road, standard close board fencing with concrete plinths and posts has been used as a boundary treatment. This material is aesthetically utilitarian and modern, and out of keeping with the historic, green character of the Conservation Area. These boundary treatments are often prominent in views, impacting the appreciation of the special interest of the area.

Figure 82: Replacement of low brick wall with concrete, which is out of keeping with the material palette of the area

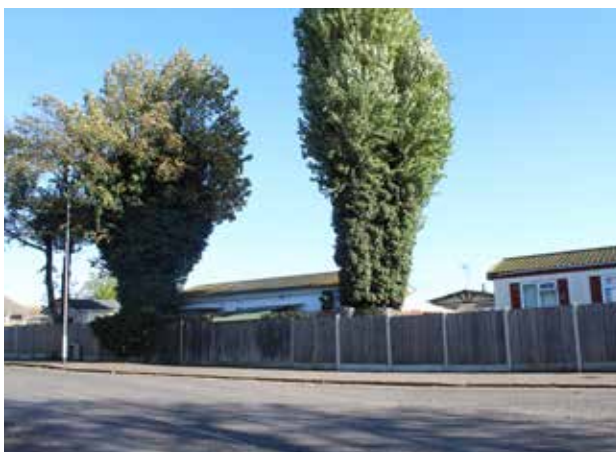
Figure 83: Example of close board fencing

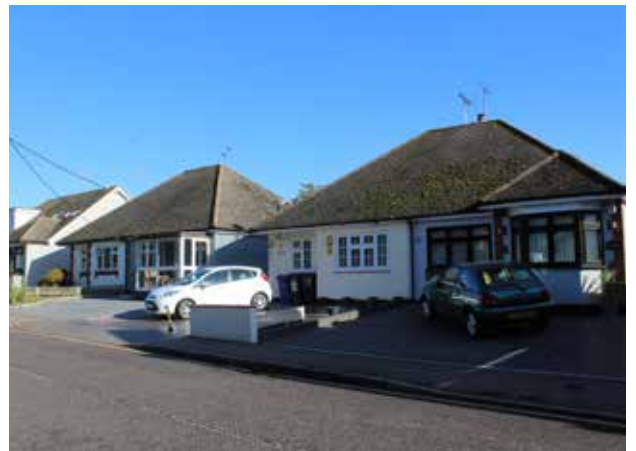
Figure 85: Twentieth century bungalows

A proportion of buildings make a neutral contribution to the character and appearance of the Conservation Area. The dilution of positive buildings amongst those which are neutral can lead to indistinctive overall character. It is considered that and twentieth century bungalows on Church Road and modern development to the north of Chestnut Walk make a neutral contribution to the character of the area, and the Chalet Park makes a neutral/negative contribution. These developments introduce new mass and grain to the area, often with inappropriate boundary treatment.

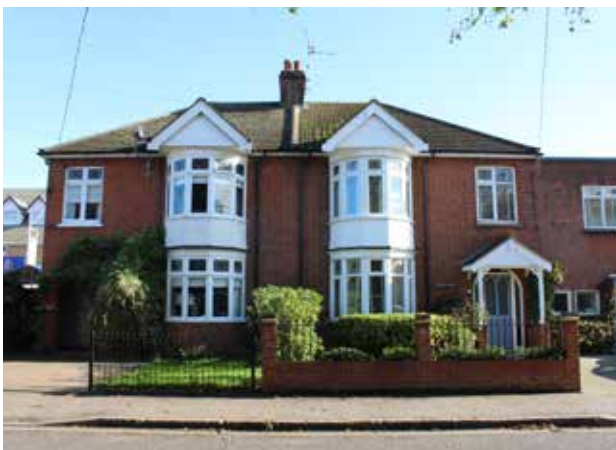
Figure 86: Two dwellings showing the impact of alterations. Window replacements, concrete roof tiles, porch and a garage extension have affected character.

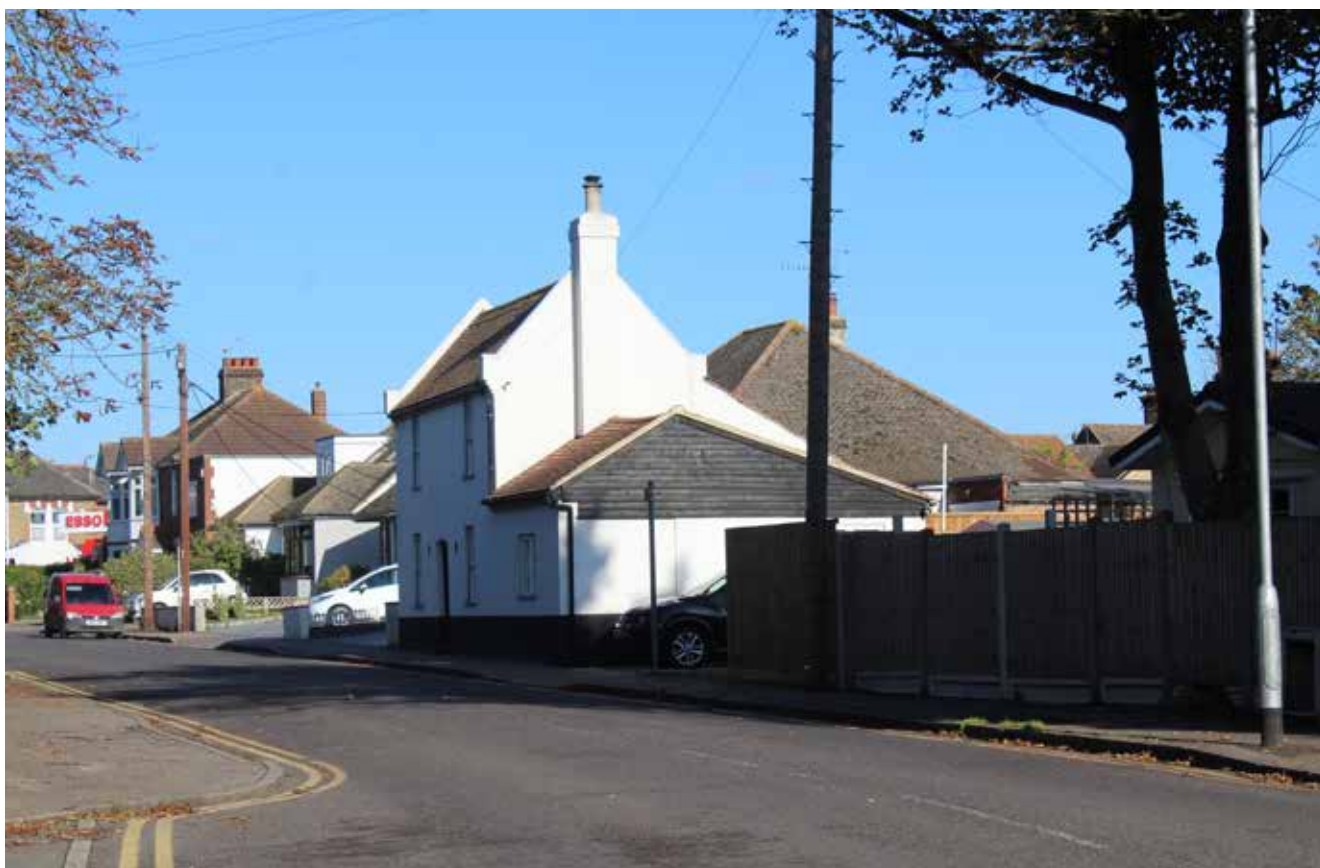
Figure 88: View north highlighting lack of trees and hedgerows as boundary treatment

The character of the Conservation Area Church Road is defined as much by the trees and hedges which line it, providing a sense of enclosure, as it is by the buildings. This is especially prevalent where the buildings are set back from the road behind grass verges and garden plots. In some places, trees and hedges have been removed or not replanted when land has been developed. This has had a negative impact upon the character and appearance of the area.

Within Corringham, a tree strategy could be undertaken to identify the most significant trees in the Conservation Area. This could lead to further Tree Preservation Orders and could also identify general tree management issues. A replacement strategy should also be considered in order to manage the impact

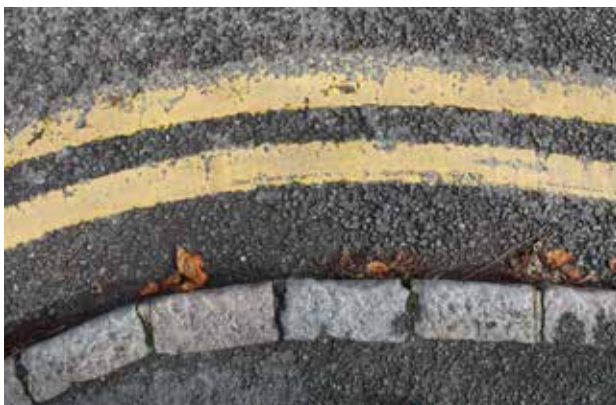
Figure 89: Stone kerbs along pavement

A key opportunity to enhance the character and appearance of the Conservation Area is through investment to improve the public realm. This can be achieved through rationalising existing street furniture and ensuring consistency and quality in new street furniture which may be added. Within the Conservation Area, some areas of pavement are lined with high quality stone kerbs; this makes a positive contribution to the character of the area and should be maintained where it currently exists and replicated elsewhere.
